Roof damage by hurricane force winds in Bermuda

The Fabian Experience, September 2003

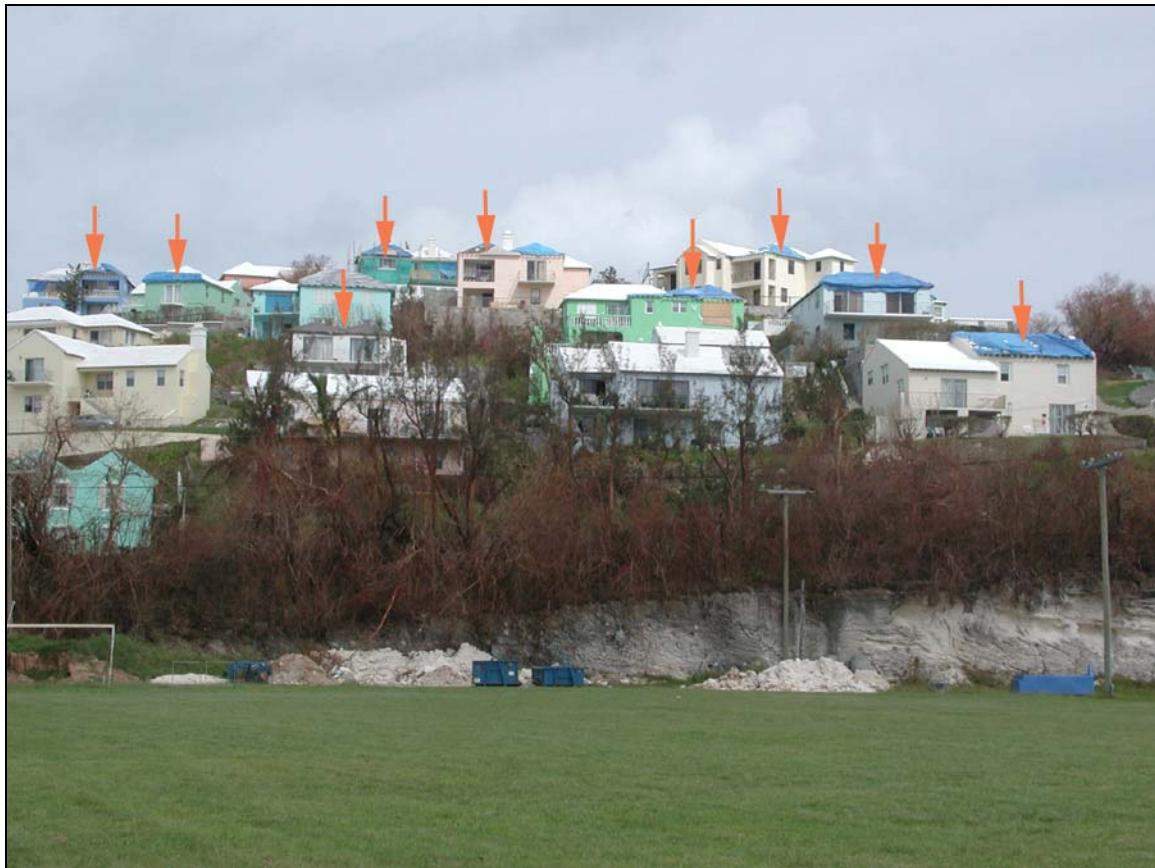
Observations clearly demonstrate the importance of topography. Structures protected by hills to their east and south, remained largely unscathed, while up to 80% of houses on certain south facing hillsides suffered damage (Figures 1 and 2). This could be explained simply by the level of exposure of these houses to strong sustained winds and very powerful gusts. However, the upward deflection of wind meeting a hillside may be an important factor. It reduces the angle of attack of the wind on a sloping roof, which has the same effect as reducing the roof pitch. As mentioned earlier, maximum suctions are known to occur where the effective pitch (the angle at which the wind meets the roof surface) is about 15 degrees.

Figure 1. Widespread roof damage on south facing, Loyal Hill, Devonshire.

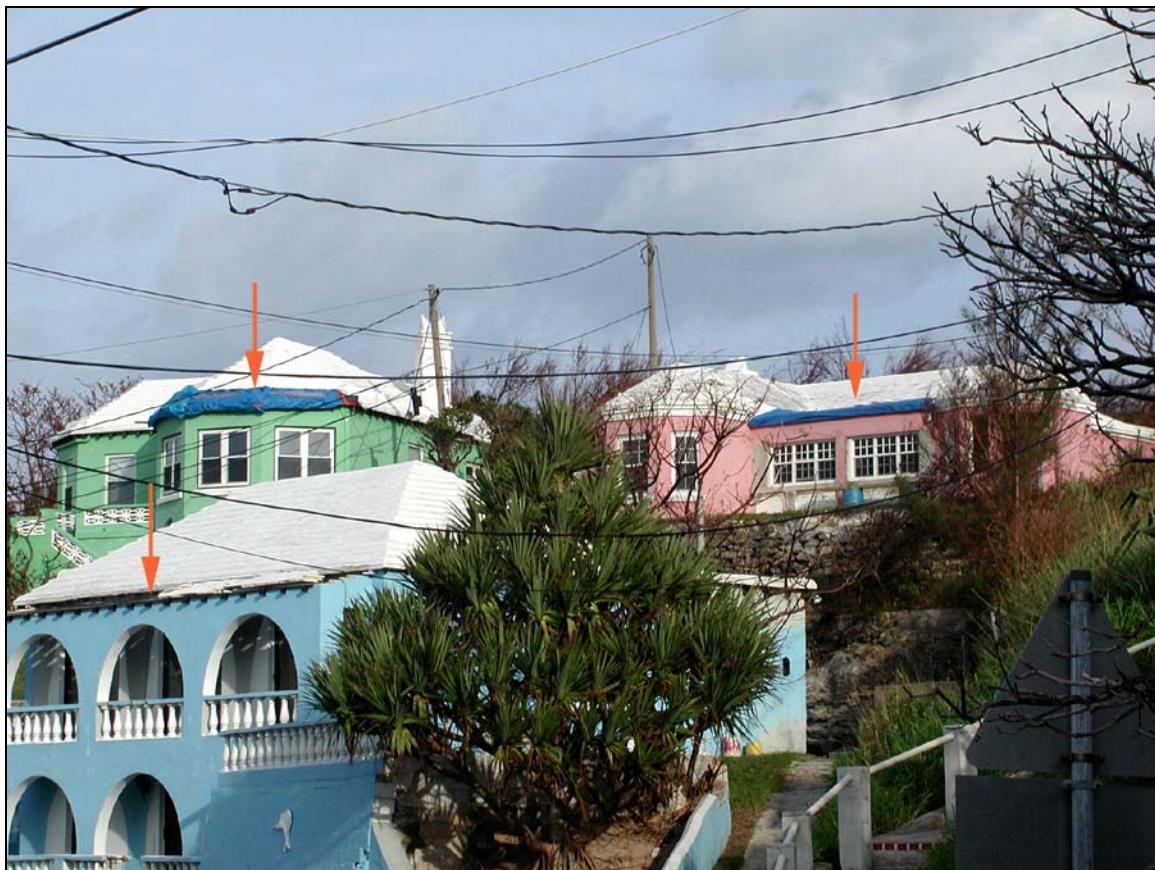
Leading-edge roof damage, resulting from Fabian, was prevalent. This is where a relatively narrow strip of slate was removed along the windward edge of a roof (Figure 2, 3, 7, 8 and Appendix I). Interestingly, where this damage did occur, it was usually the only roof damage. Despite high suctions that can occur on the leeward side of the roof, damage in this area was almost absent except where it could be attributed to “blowout” (see later).

Figure 2. Widespread "leading-edge" roof damage on south facing Mullet Bay Road, St George's.

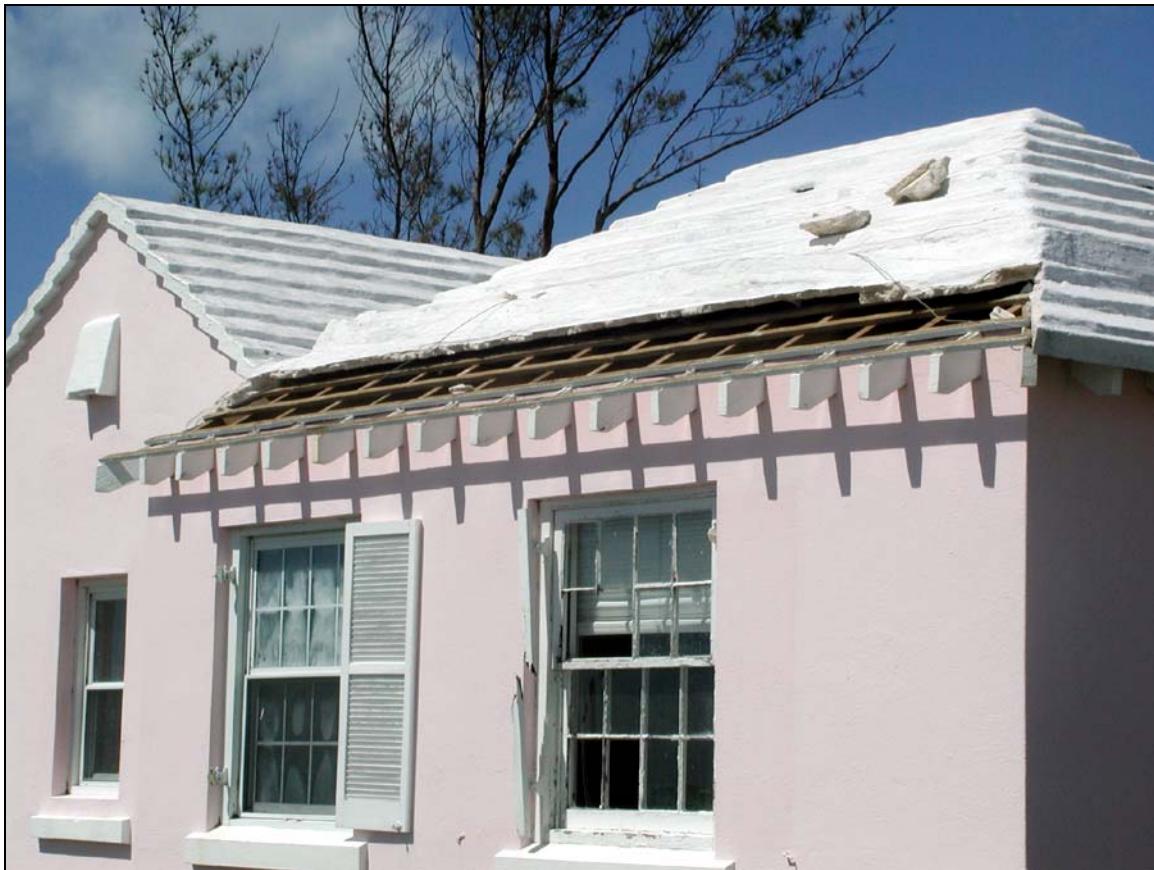
Figure 3. Typical leading-edge damage. Berry Hill Road, Devonshire (south facing).

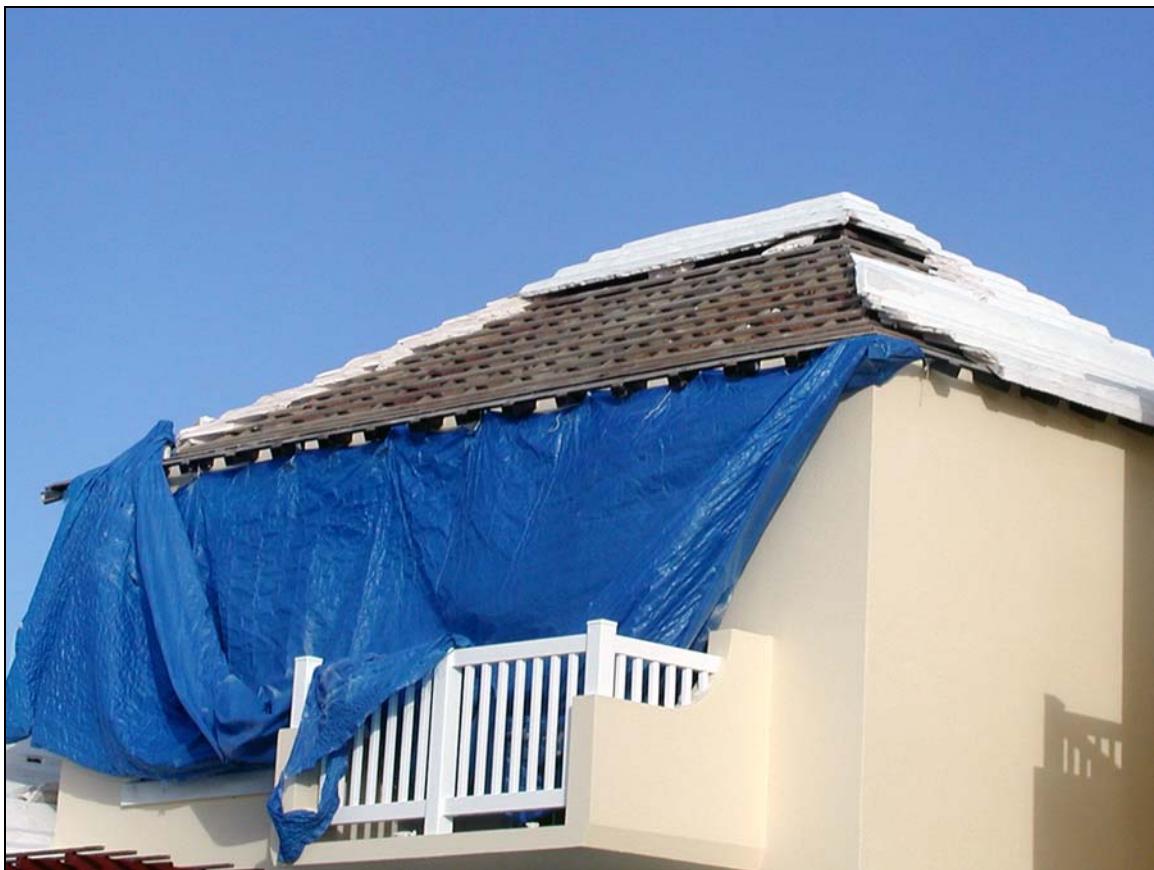
Figure 4. Less typical, extensive slate loss on windward side. St George's Club (south facing).

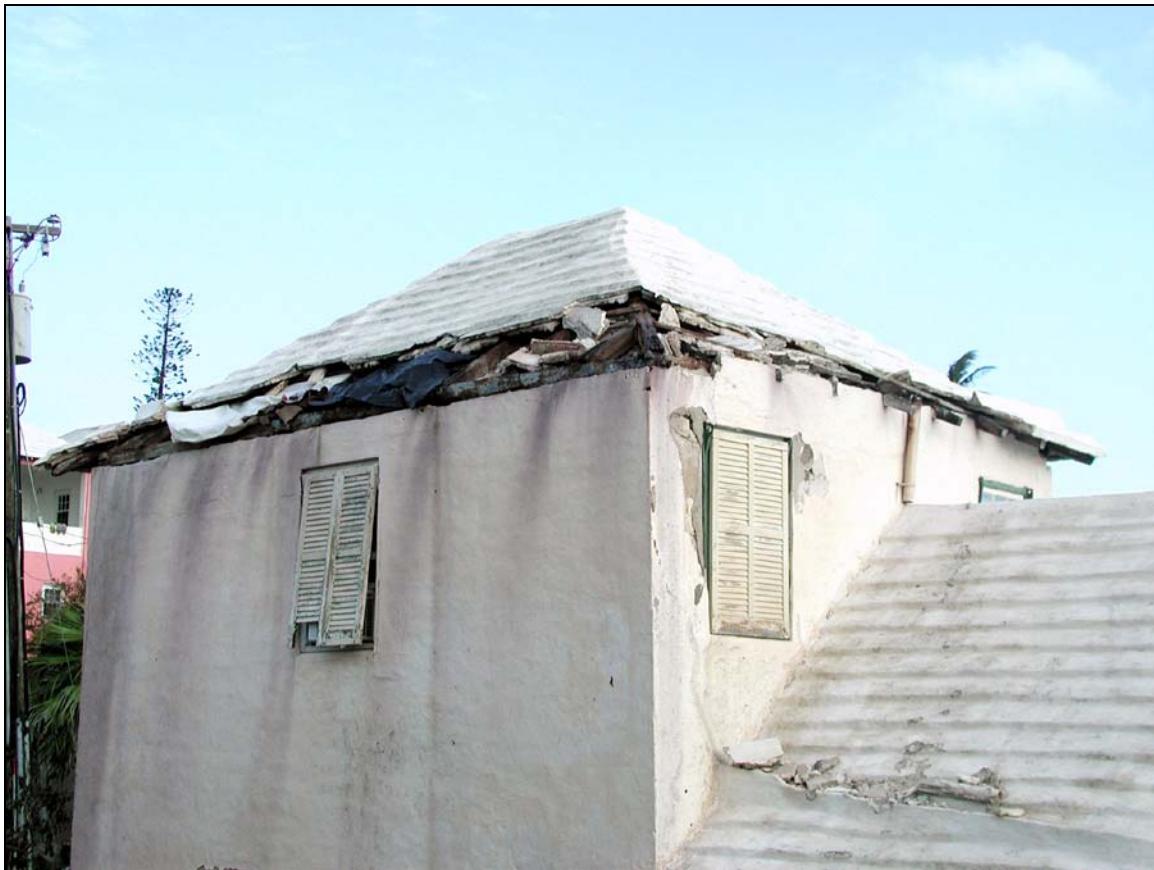
In Bermudian houses, the gap between the roof and the wall plate is in some cases closed between the rafter feet, and in others open (often in older houses). In other words the “fill slate”, or equivalent barrier, shown beneath the eaves in Illustration 6, may be absent. This, obviously, greatly affects the connection between the “attic” and the outside atmosphere. However, both the sealed and unsealed types failed during Fabian (Figures 5, 6 and Appendix IV) and many of each type survived.

Figure 5. Historic house in St George's with exposed rafters (east and south facing).

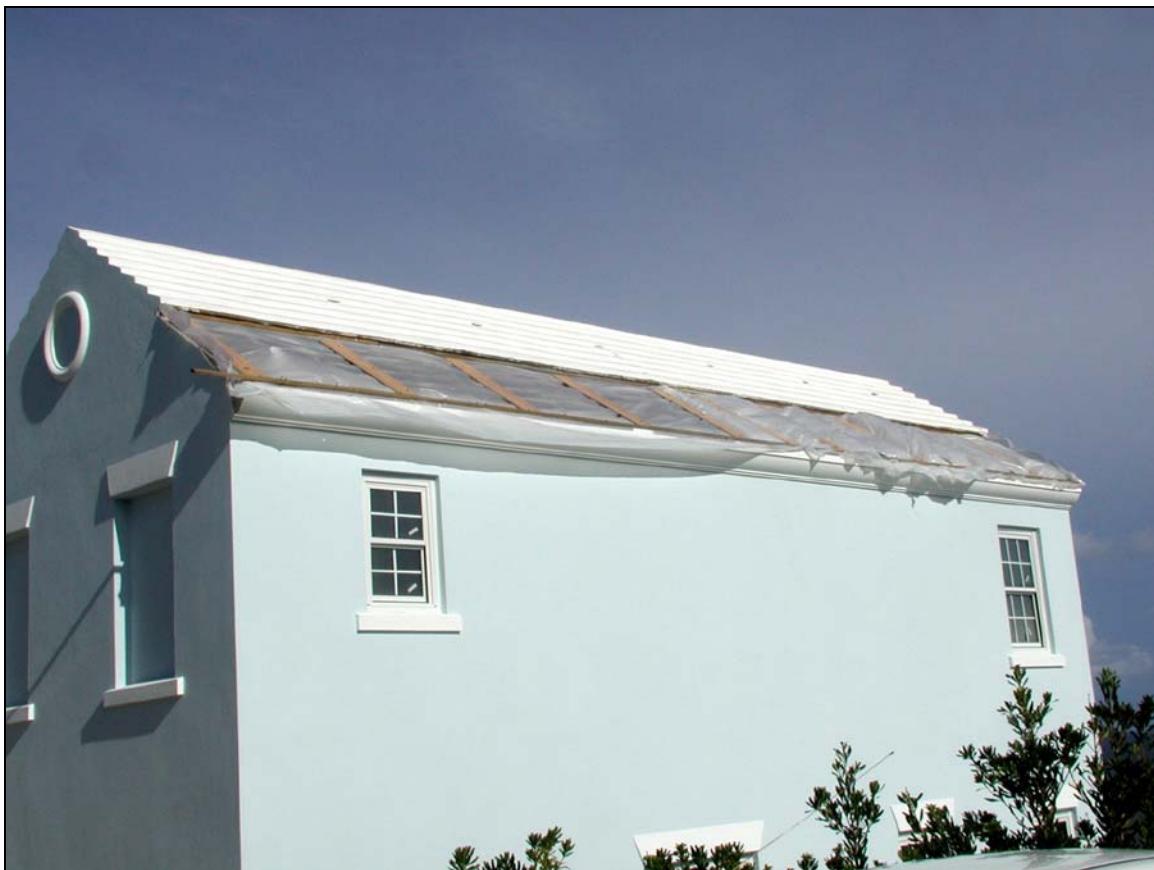
Figure 6. Newly built house on Knapton Hill with enclosed rafters (west facing).

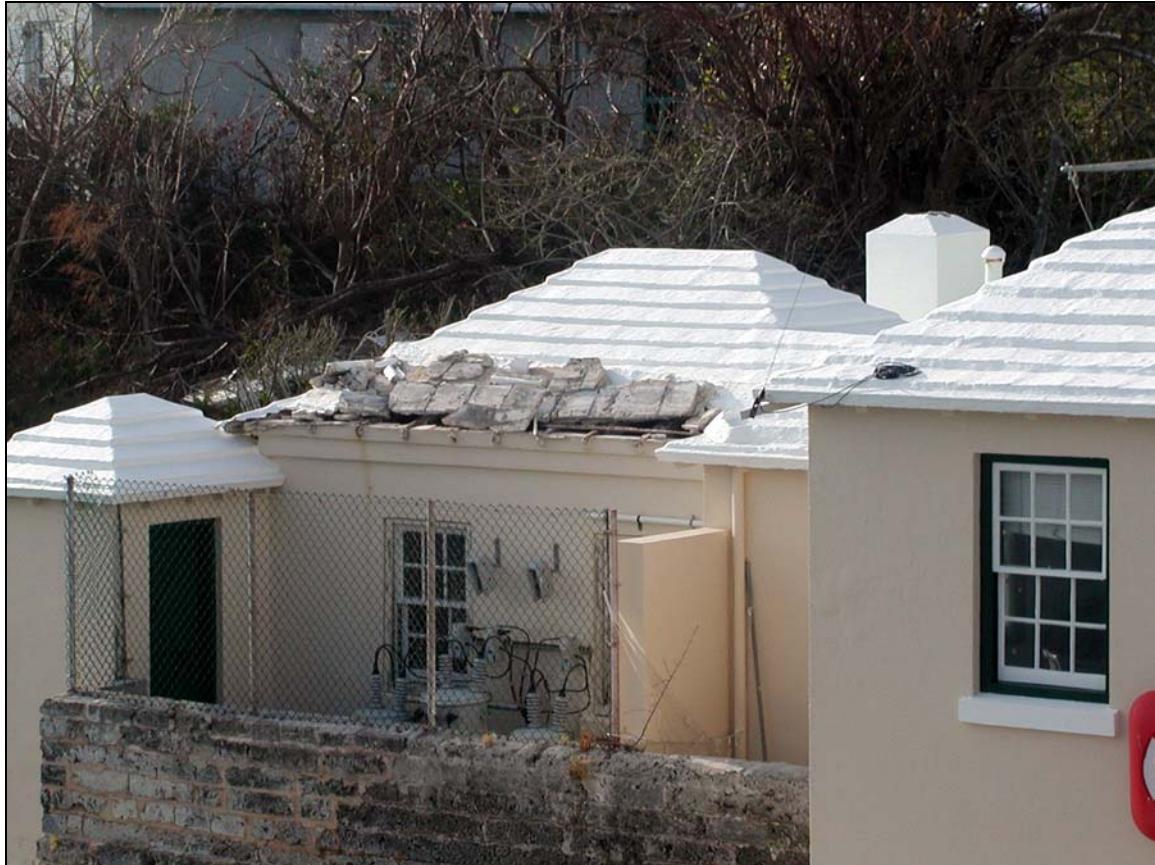
Figure 7. Leading-edge, "peel back", Swing Bridge St George's (south facing).

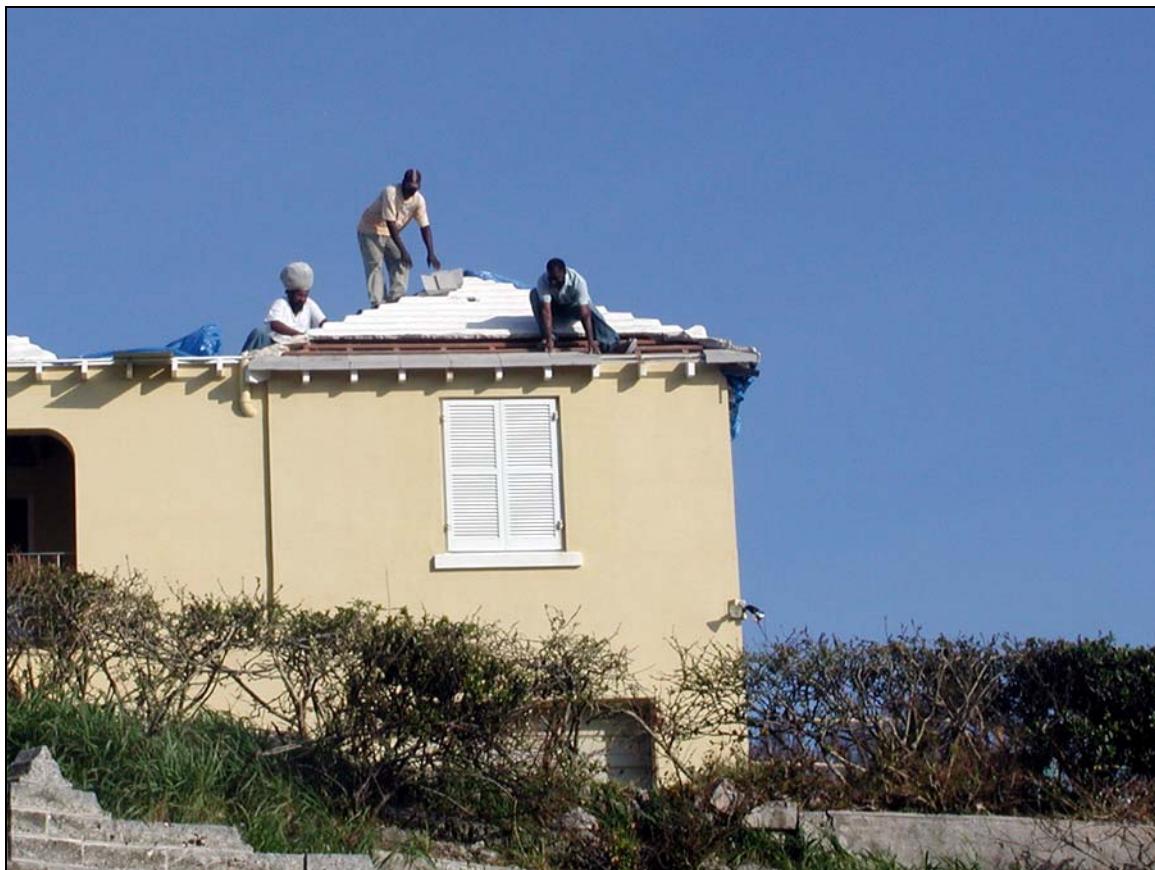
Figure 8. Leading-edge damage, Sayle Road, Smith's Parish (south facing).

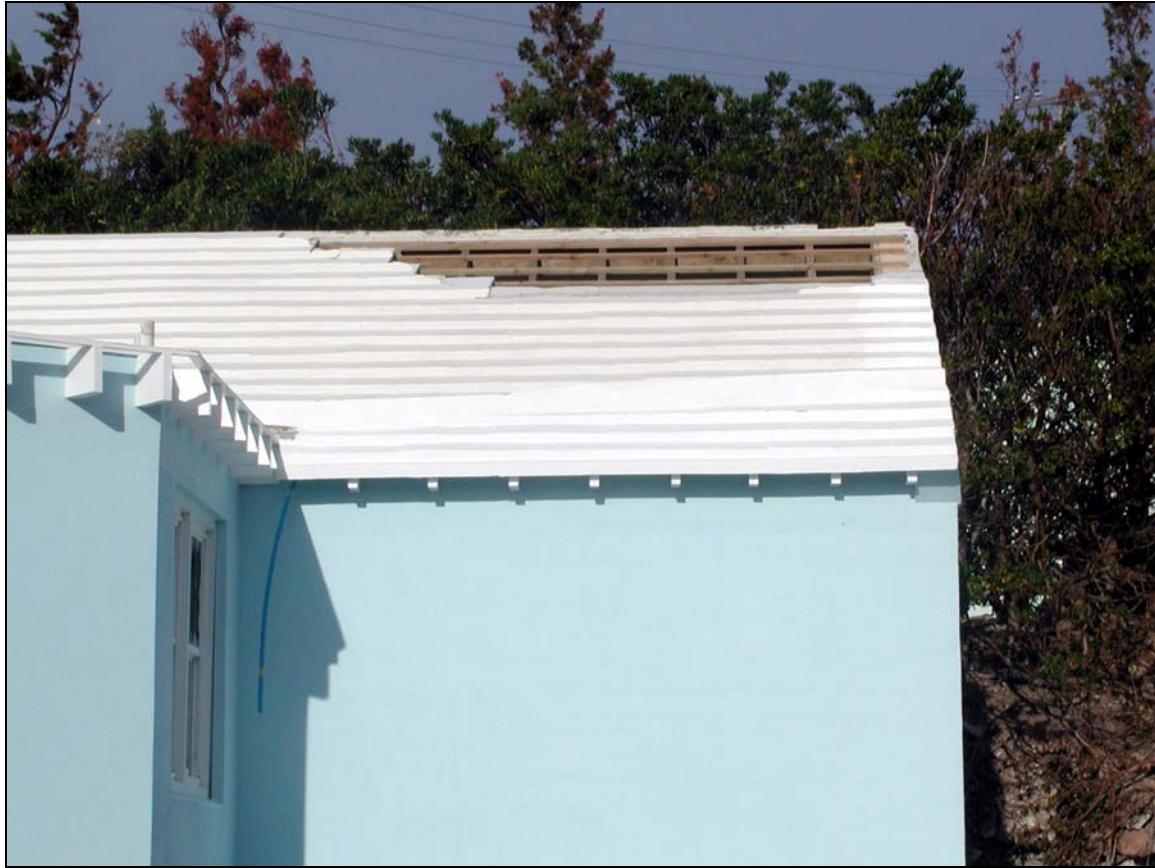
Several variations of roof damage did occur. In a number of cases, there was the removal of slate at, or near, the roof crest while the edges remained intact (see Figures 9 and Appendix V). This seems, often, to have occurred on roofs with gable-ends which faced into the strongest winds. In other instances, where entry of the wind into the structure was possible, pressurization or “blowout” probably contributed to the damage. Verandahs and bus shelters were particularly vulnerable where they suffered from, both, the leading-edge effect and from wind entry (see Figures 10, 11, 12 and Appendix II).

Figure 9. Roof crest damage, Wellington Lane St George's (west facing).

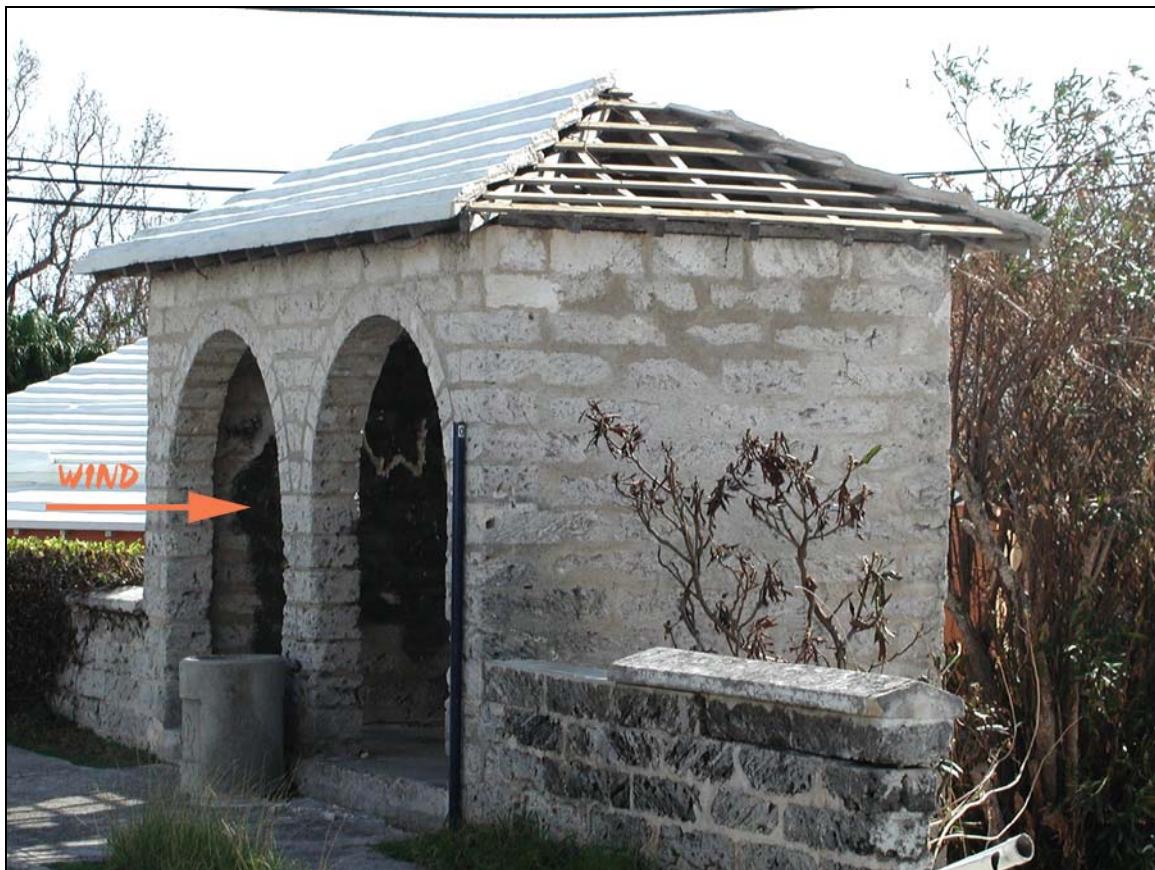
Figure 10. Rare leeward side damage. Due to pressurization within open structure. (north facing).

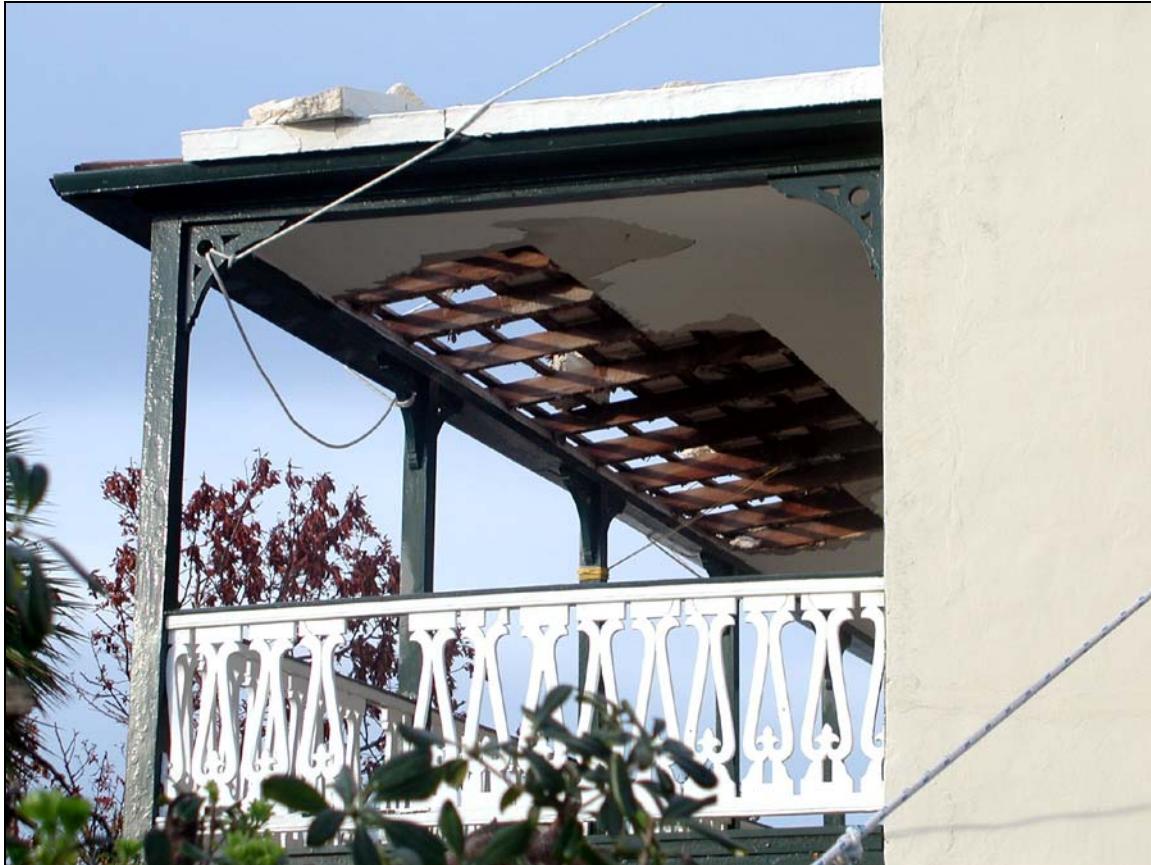
Figure 11. Verandah damage, Khyber Pass, St George's (south facing).

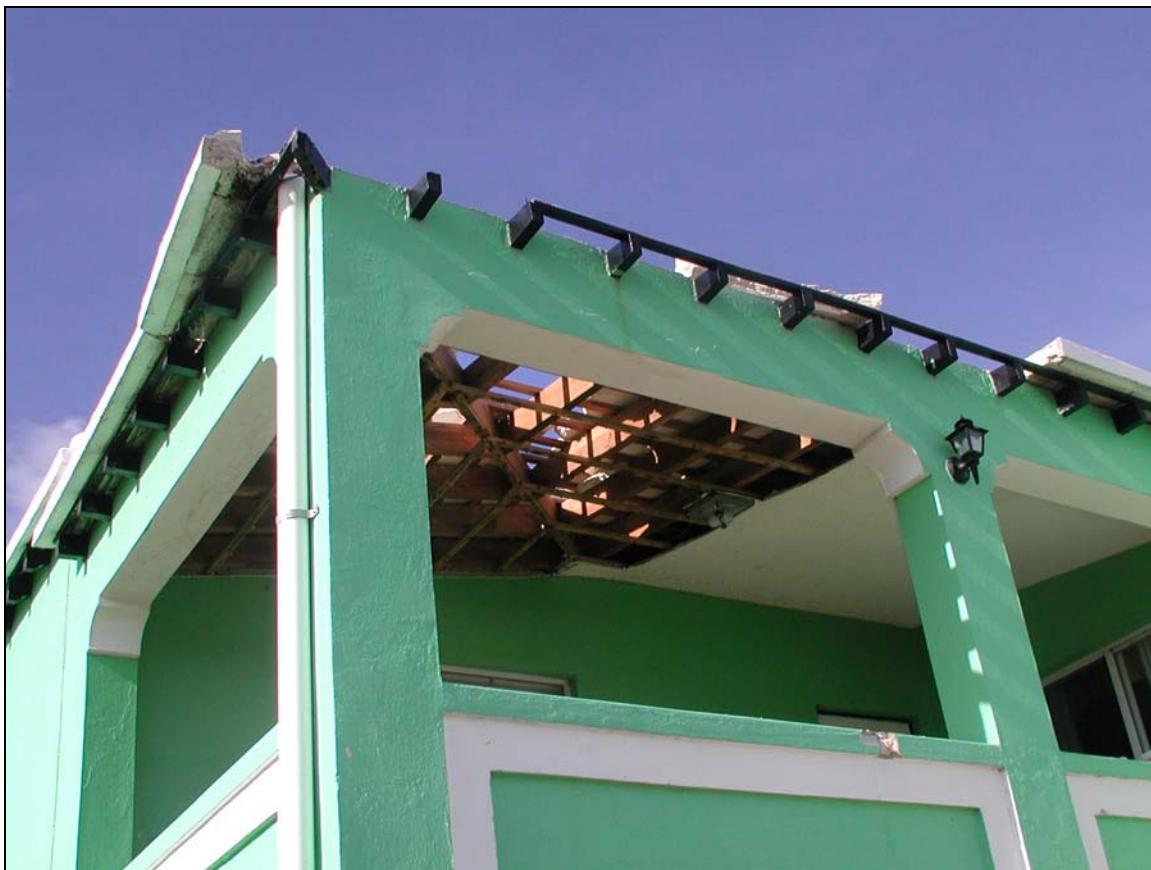
Figure 12. Verandah damage, Knapton Hill, Smith's Parish (south facing).

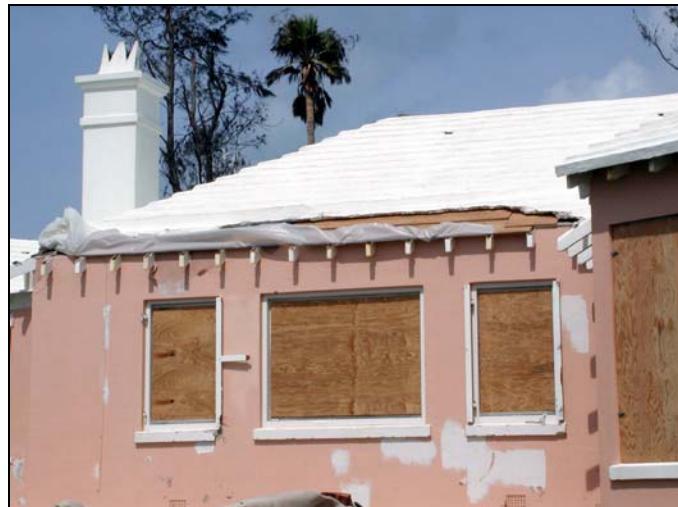
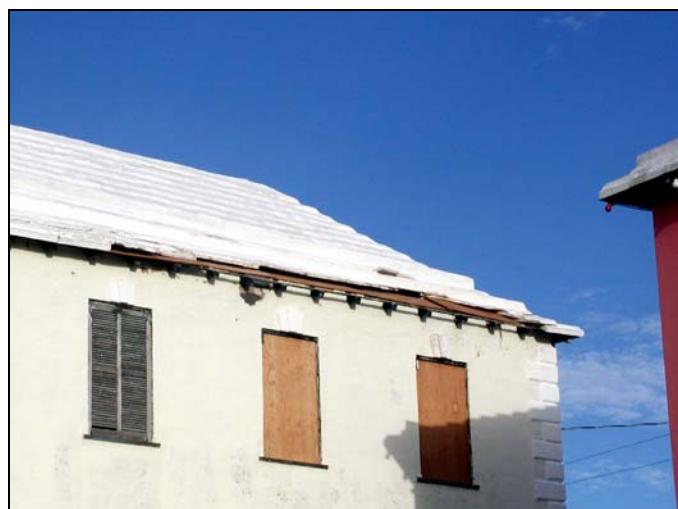
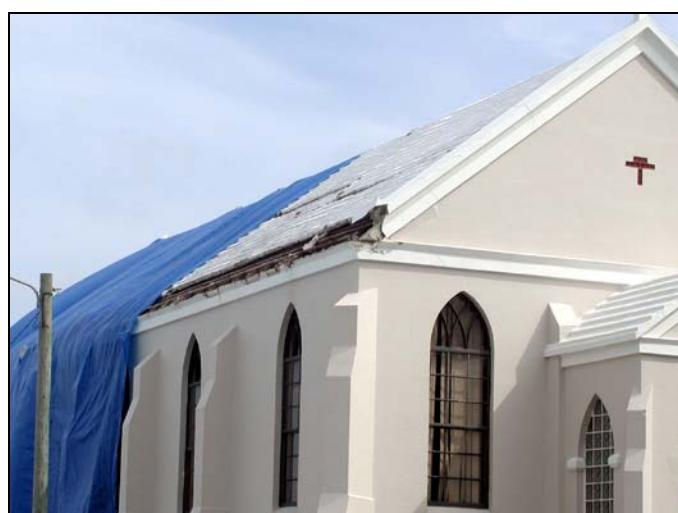
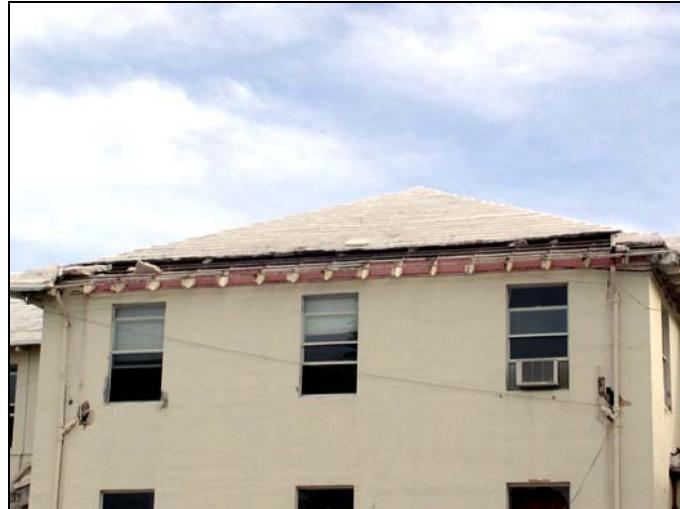
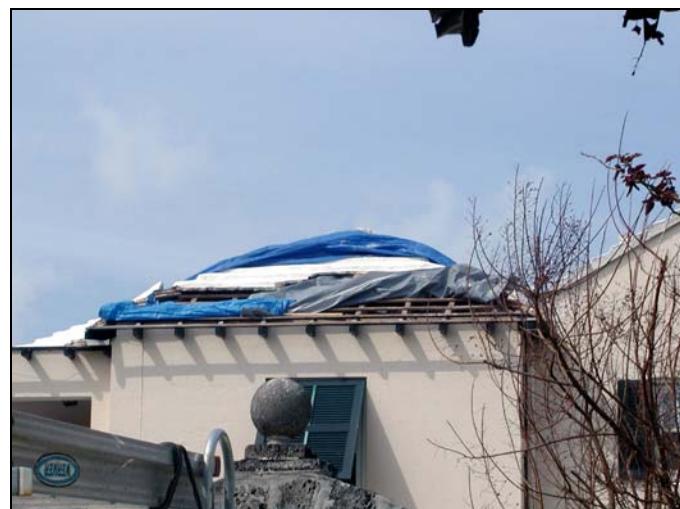
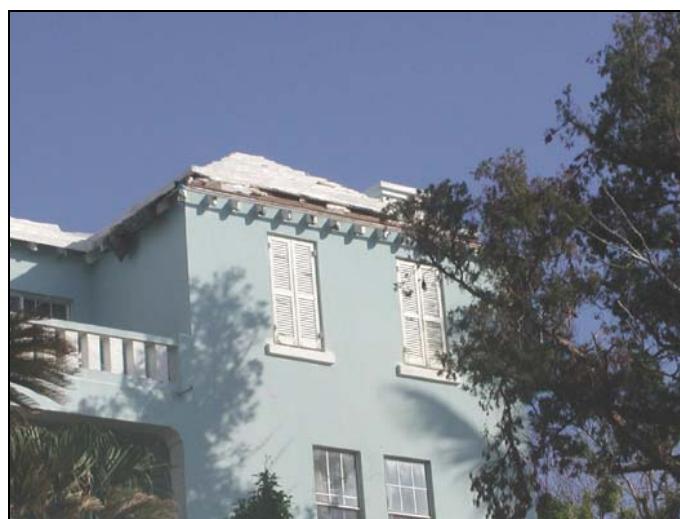
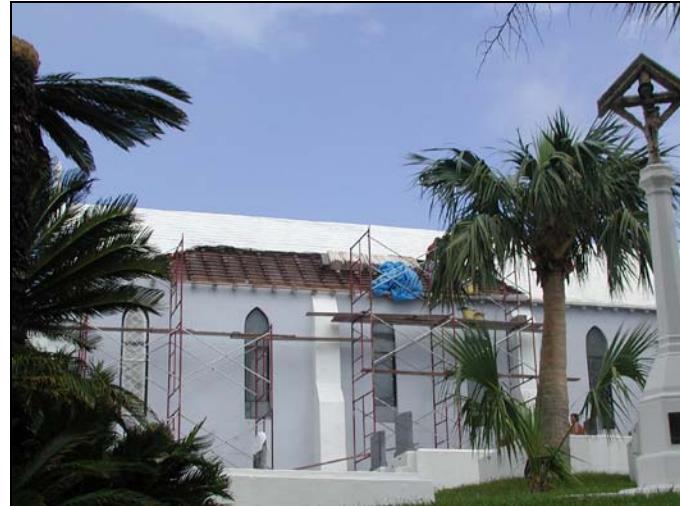
Photographs showing damage on the leading, windward, edge of the roof, as was experienced by the vast majority of houses, which suffered roof damage.

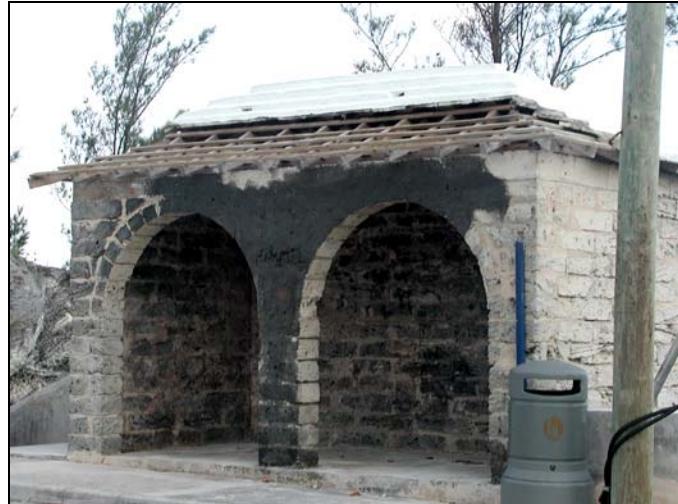
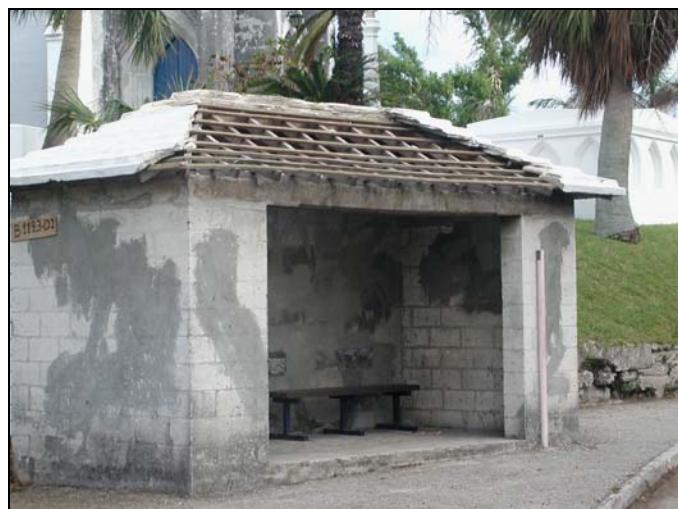
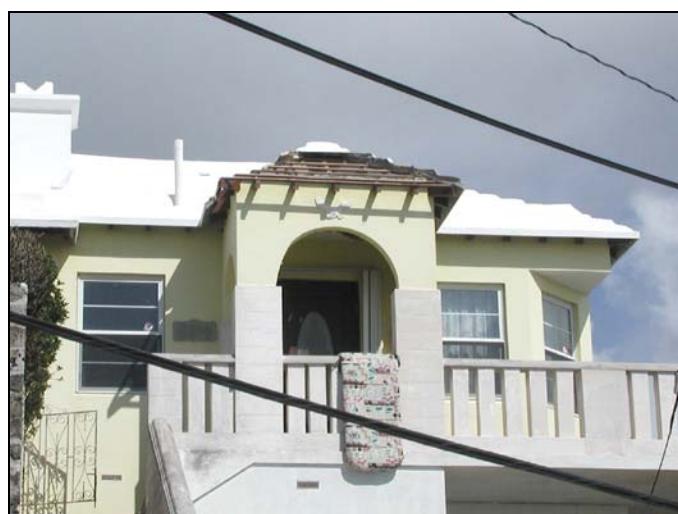
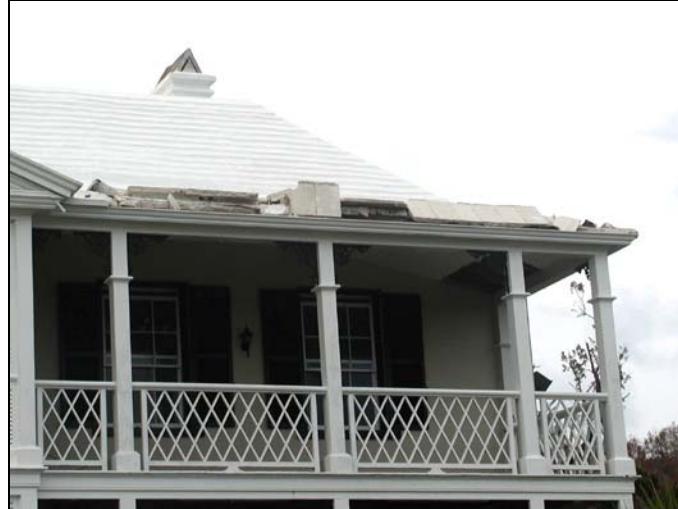
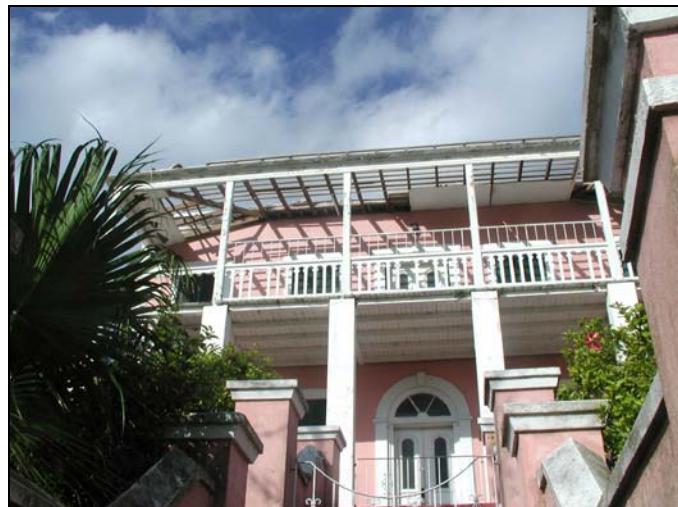
Photographs showing damage to structures with large openings on the windward side. These were exposed to pressure from trapped air below as well as suction by deflected air above.

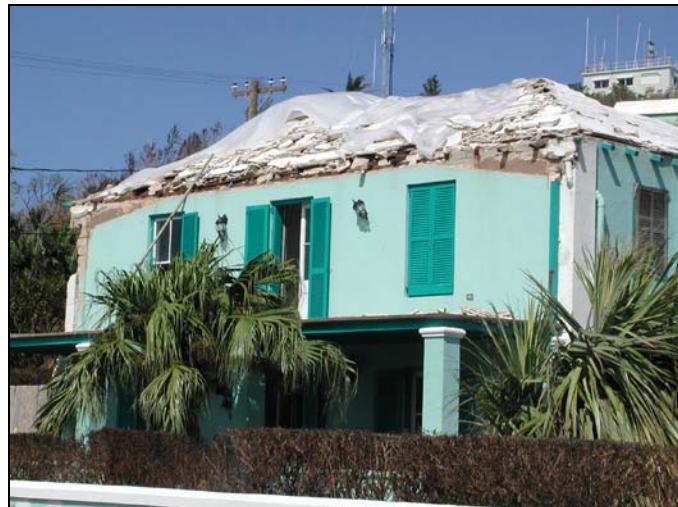
Figure 25. York Street, St George's (south facing).

Older buildings in exposed locations were particularly vulnerable. Note in Figure 25 that the verandah has been completely removed.

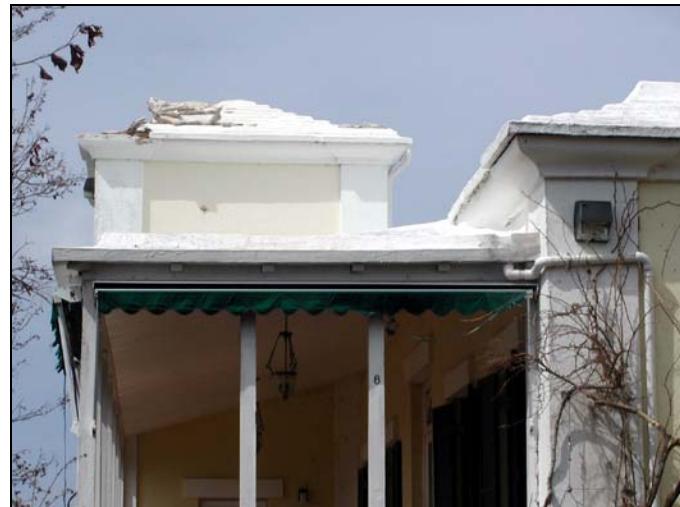
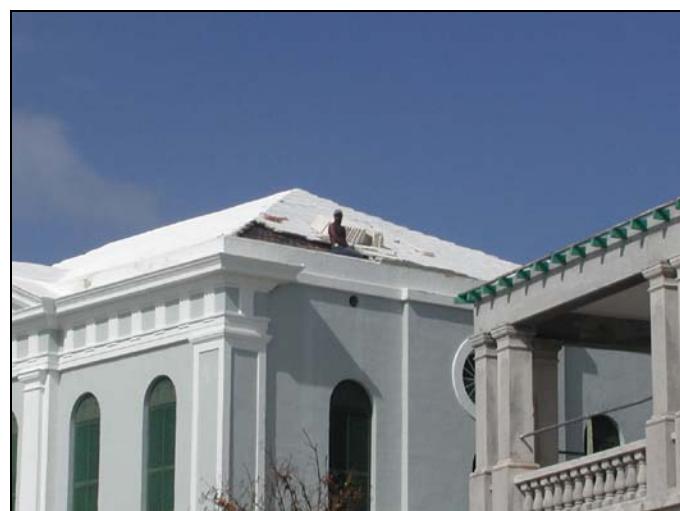
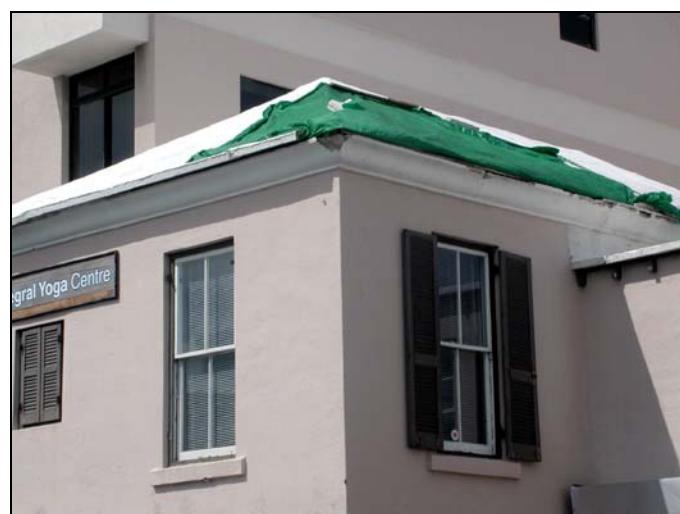
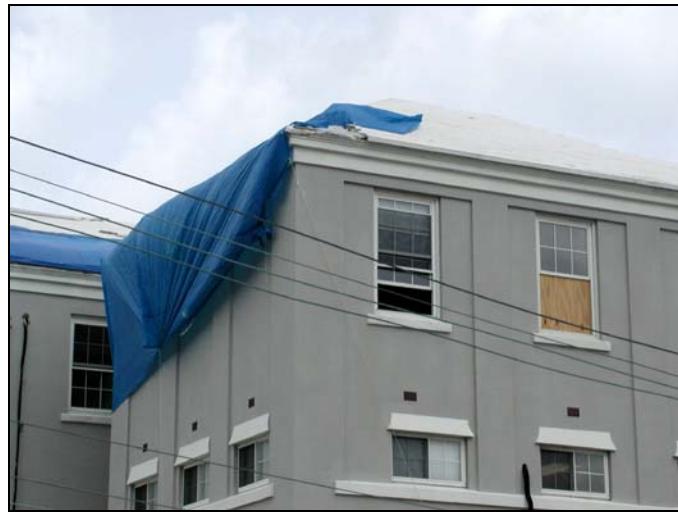
Photographs showing that buildings with decorative corner moldings, which enclose the rafter feet, were not immune to damage.

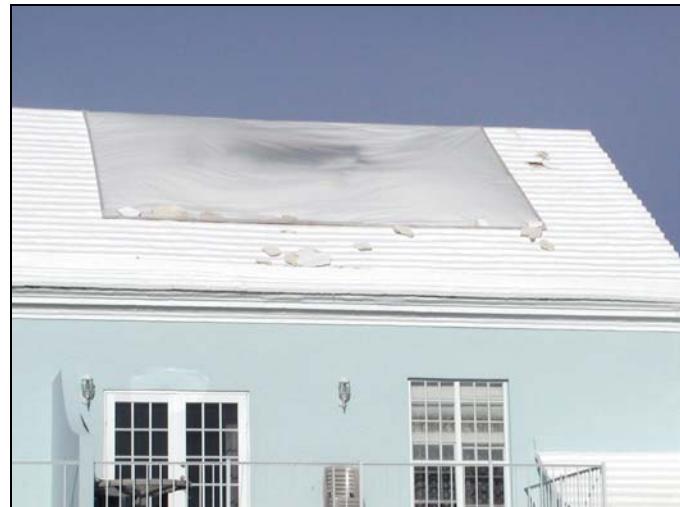
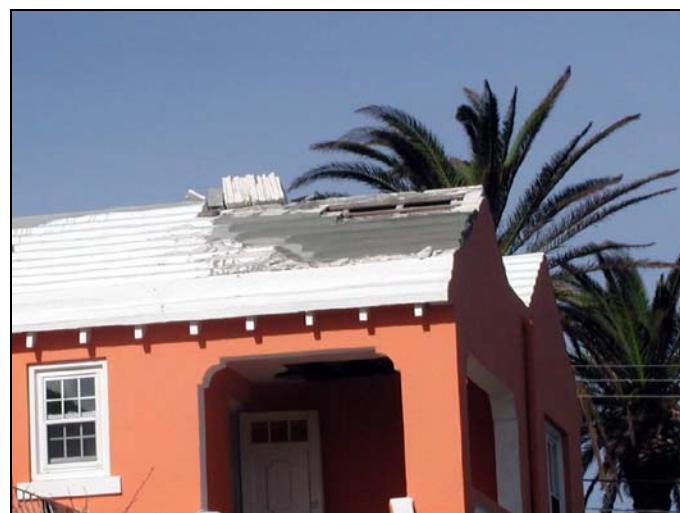
Photographs showing damage to roofs where the edges remained intact. This type of damage seemed more common in roofs with gable ends, which faced into the strongest winds. (See also Figure 9).

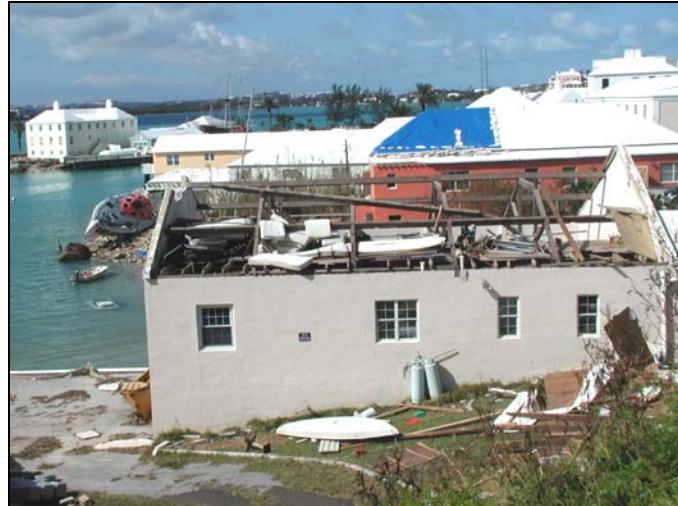
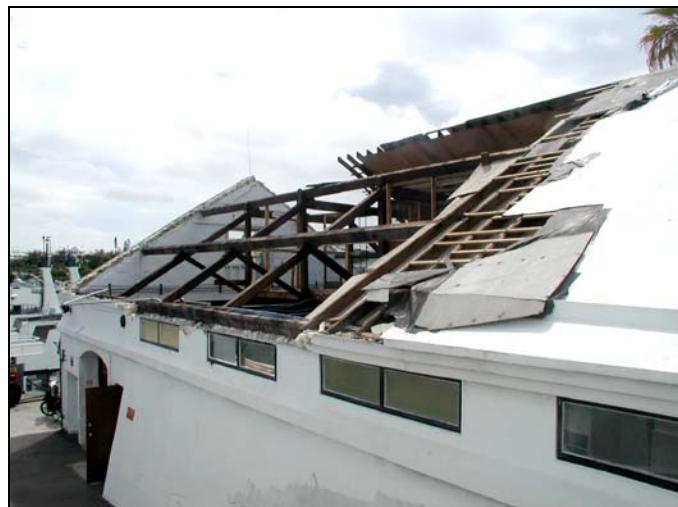
Photographs showing extensive damage to buildings with gable ends (south facing) and sheeted roofs (plywood or cement board).

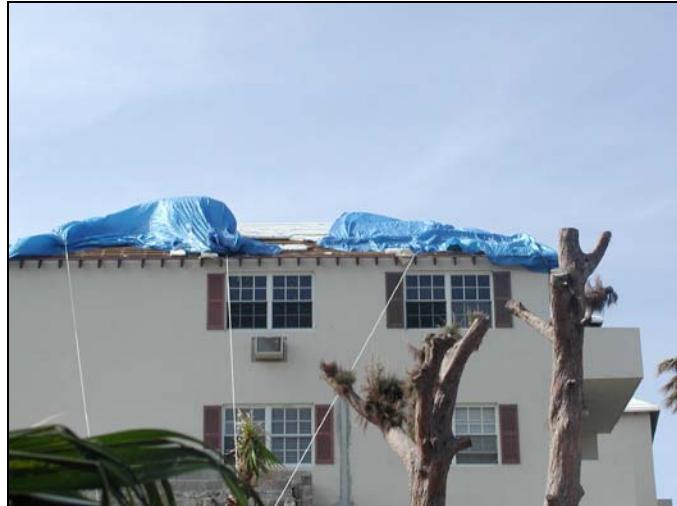
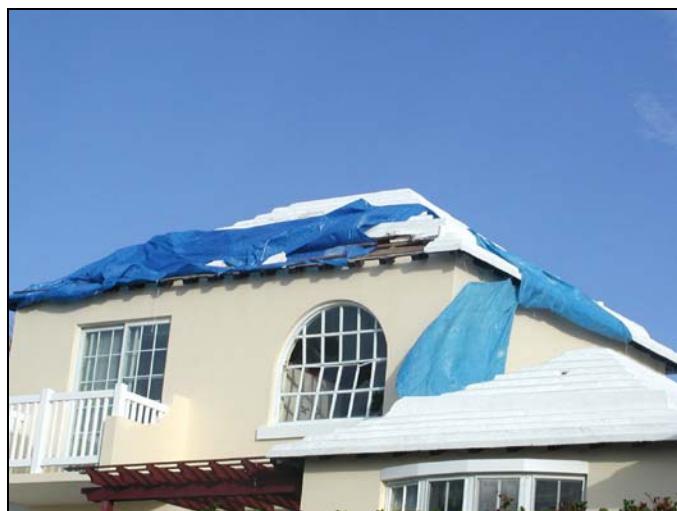
Photographs showing the inadequacy of many, temporary fabric roof coverings. Note that figures 39 and 40 were taken 2 months after Fabian hit. (Also see Figures 17 and 25).

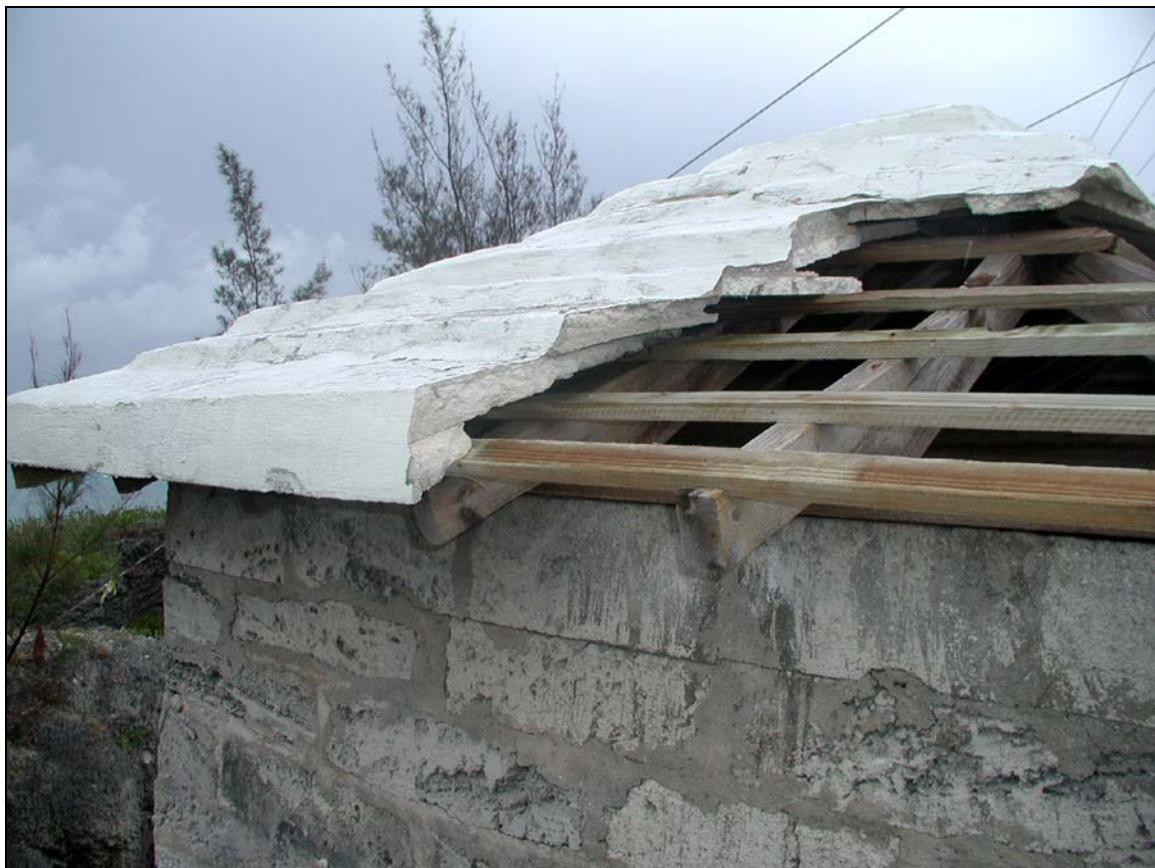
Figure 45. Damage reveals construction details of a traditional limestone slate Bermuda Roof.
